**International Aramoon Corp.**

**“Pipe Inspection and Rehabilitation”**

By: Faiz Al-Elweet

February 24, 2010

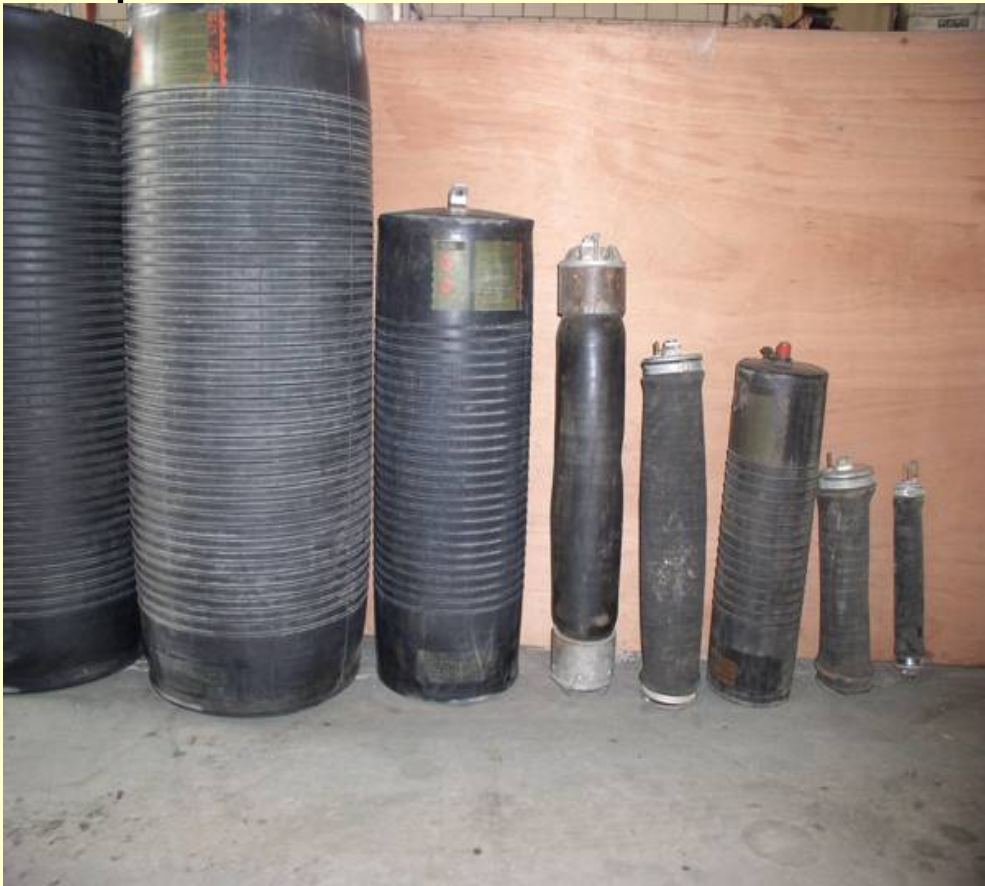
### **Pneumatic Plugs:**

Rubber plugs with variable diameters to isolate the pipeline section under inspection or rehabilitation.

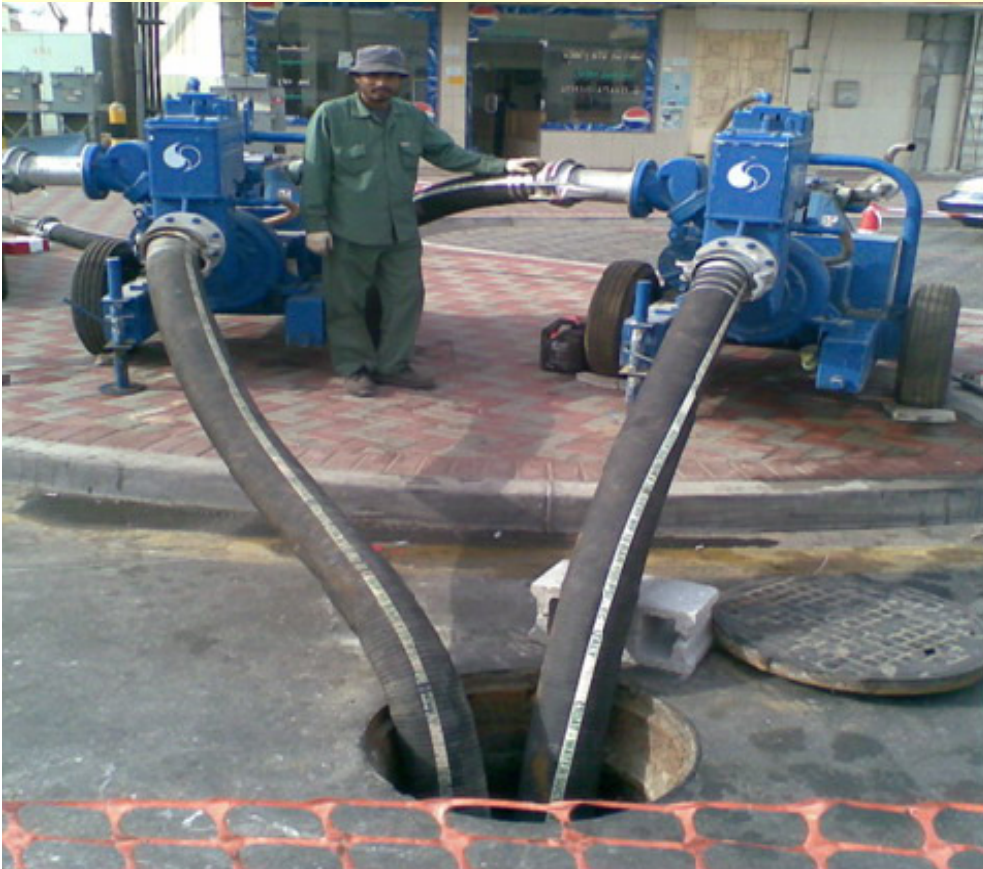
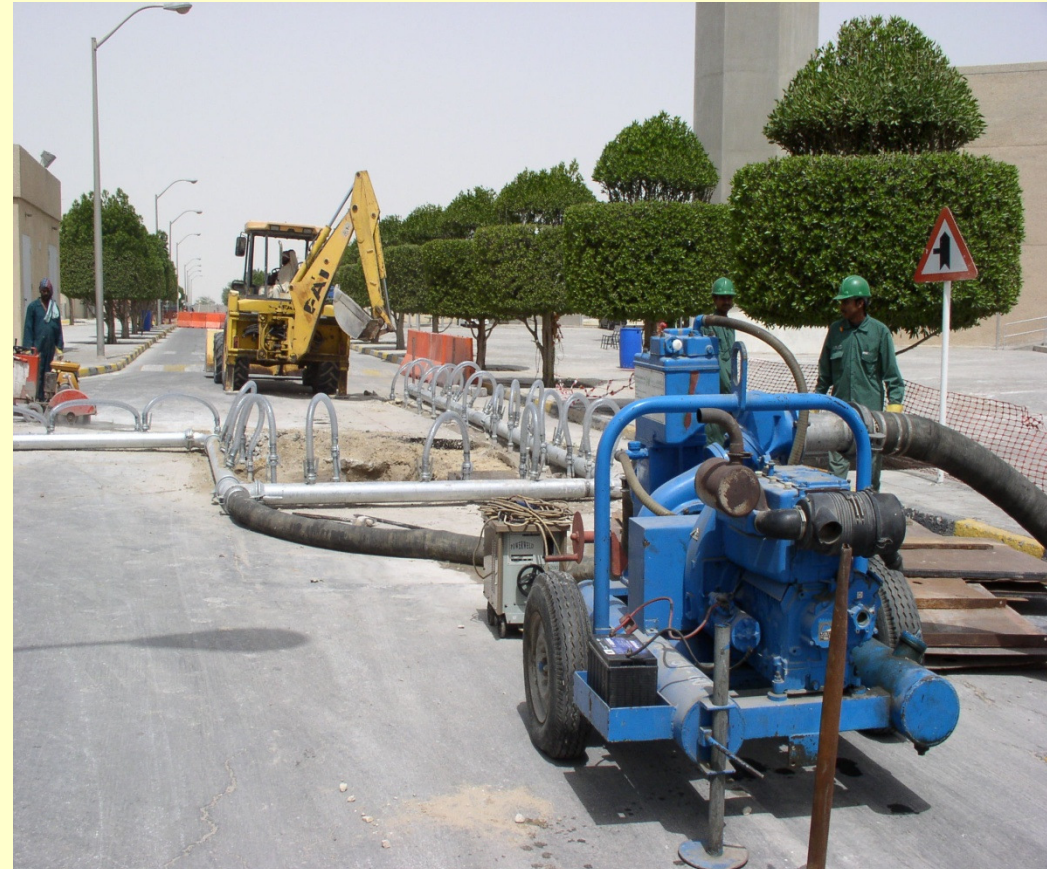
### Over Pumping (By Pass):

To divert the flow away from the pipeline section which will be inspected or rehabilitated.

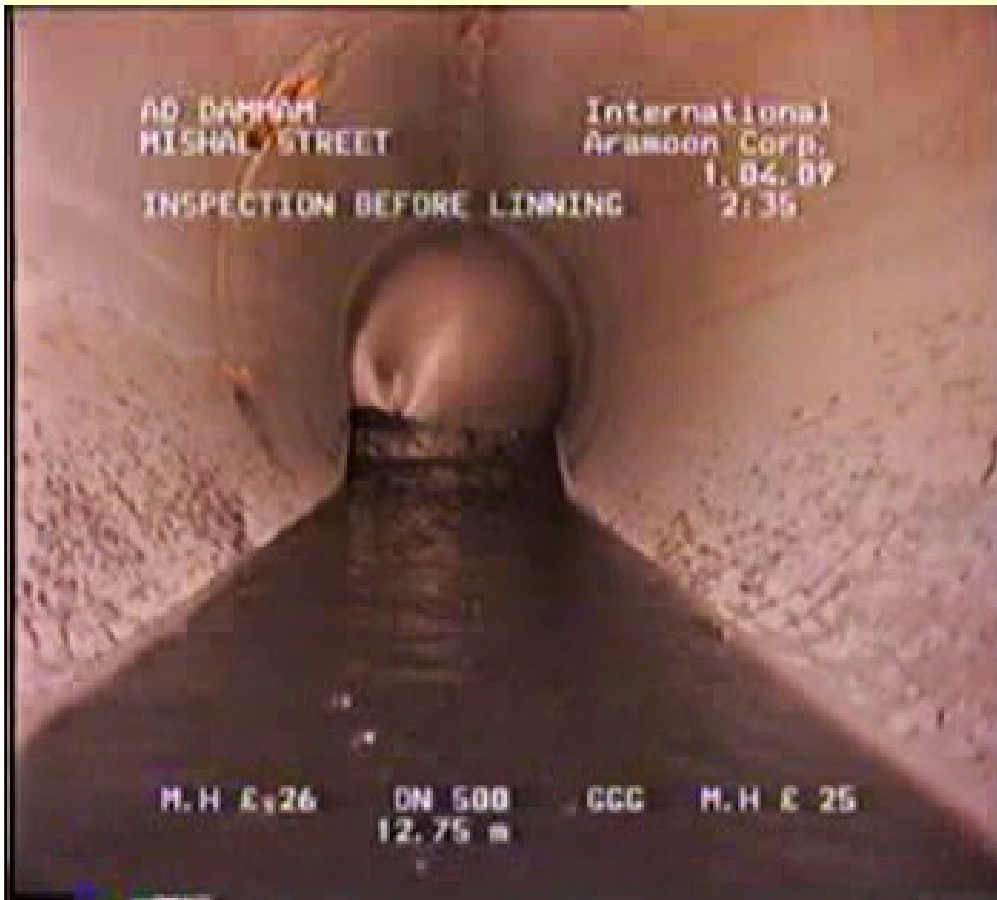
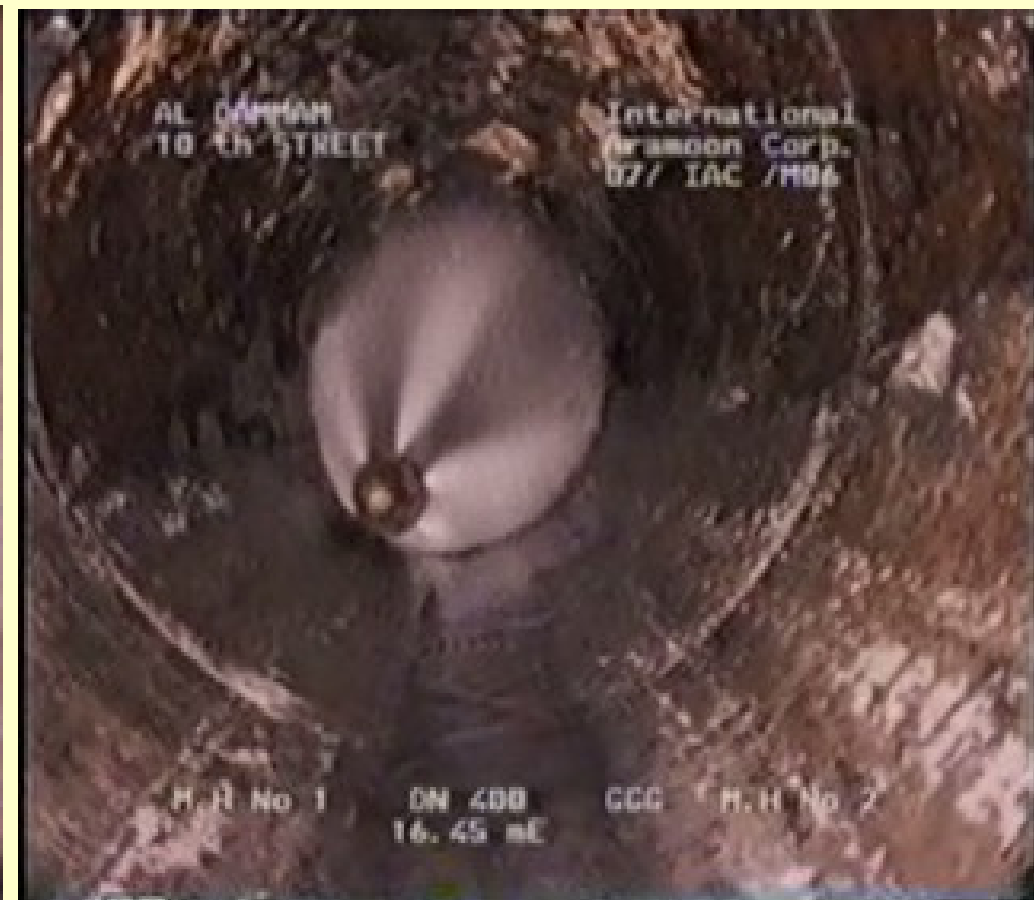
### Jet Cleaning:

To remove debris and dirt inside the pipe by using high water pressure flow.

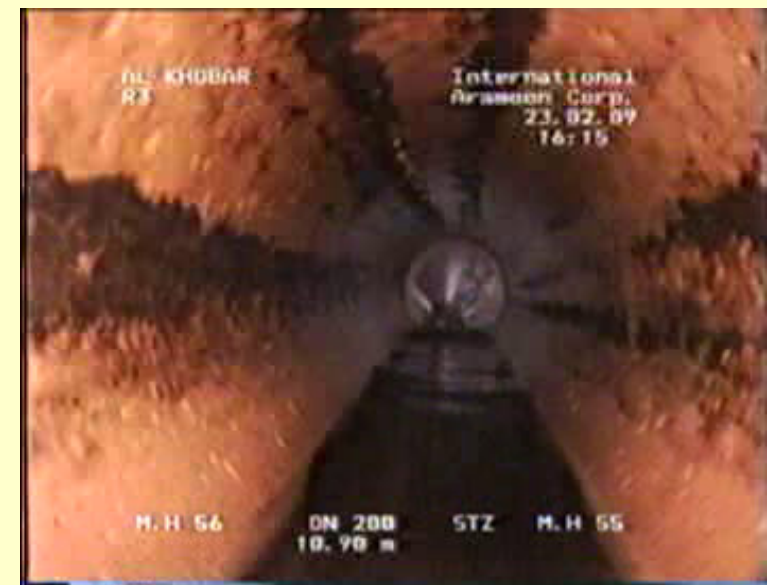
## Advantage of Jet Cleaning:

- Allows easy & accurate camera inspection.
- Facilitates repair & rehabilitation works.
- Enhances the efficiency of the sewer system.

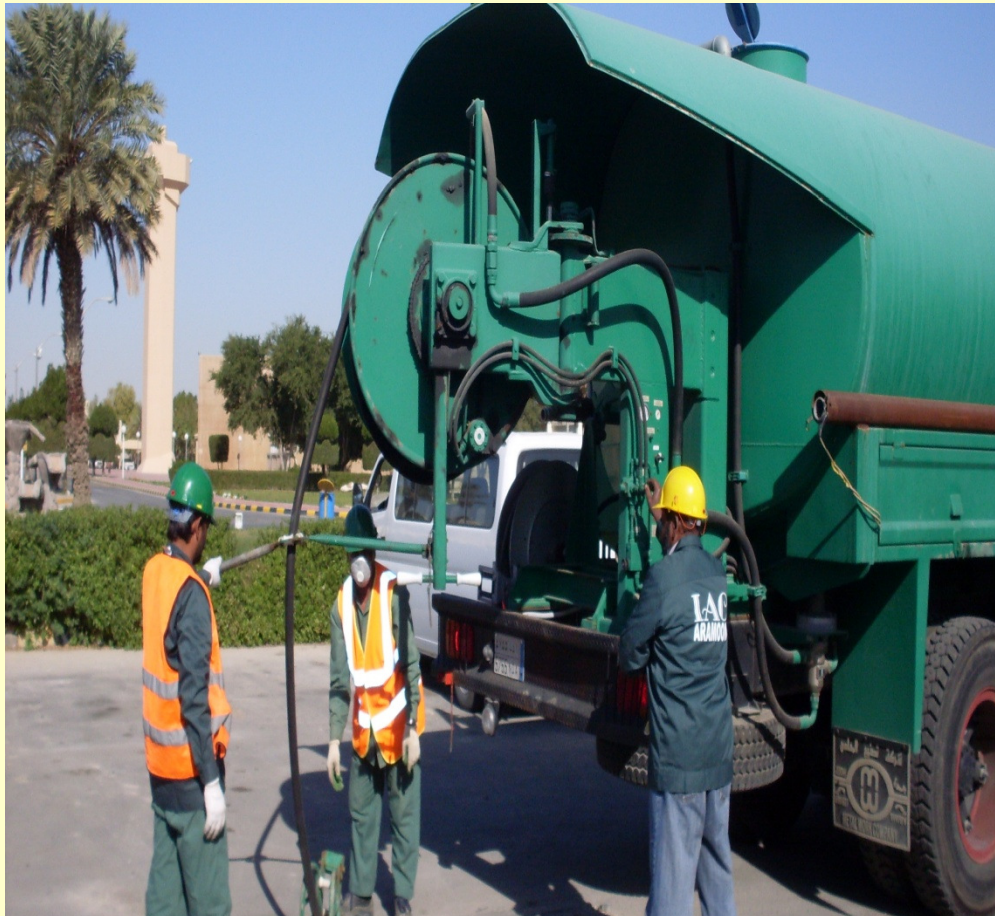
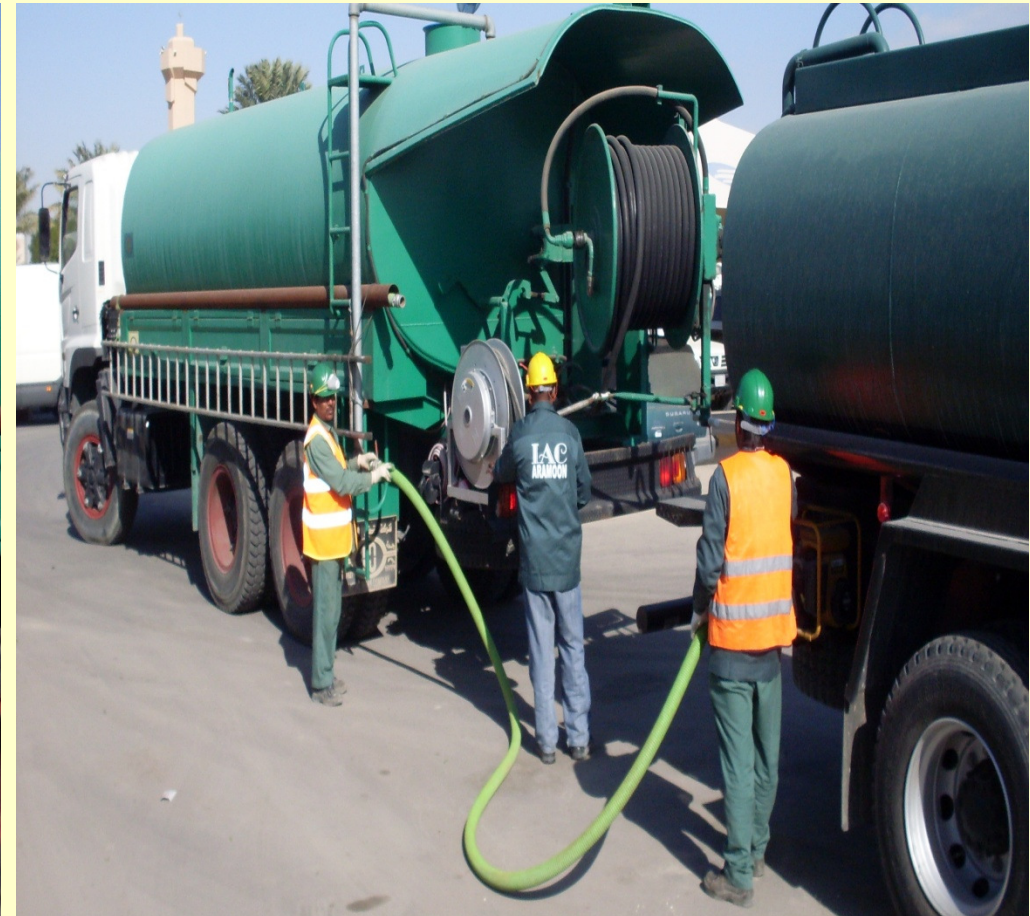
### Vaccum:

The debris and other wastes are removed from the pipelines using vacuum machine which will draw wastes outside the manholes.

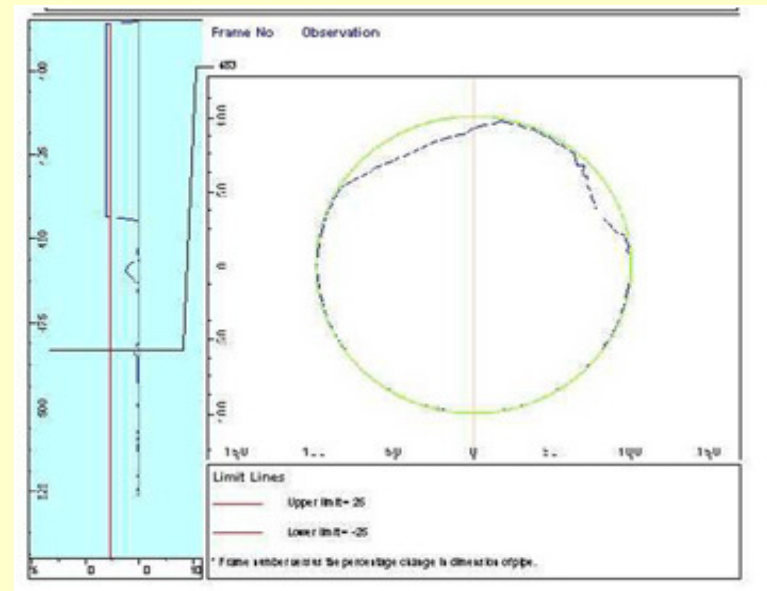
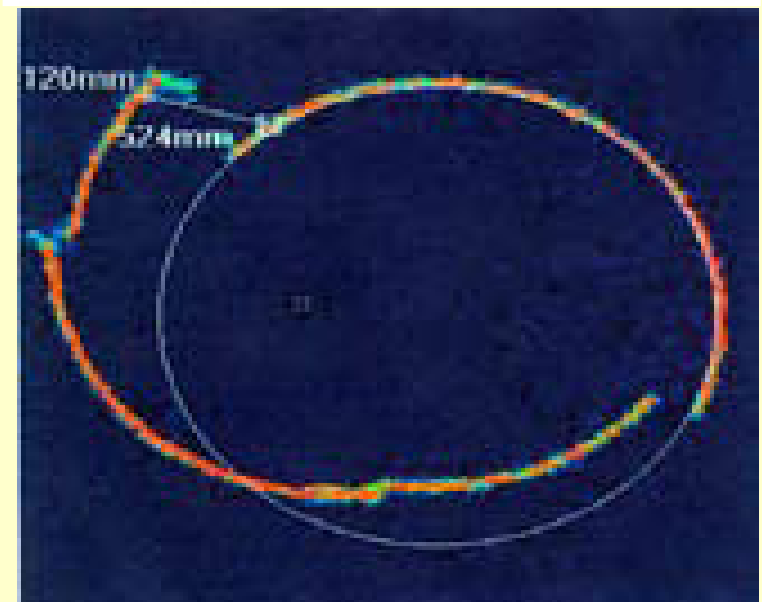
## Laser Profiler Pipe Capacity analysis Report

Laser profiling equipment is being used in conjunction with CCTV inspections to determine deformation in pipes.

Sonar technology is also becoming a common tool in application where flow within a pipeline and an image below the water surface is needed.

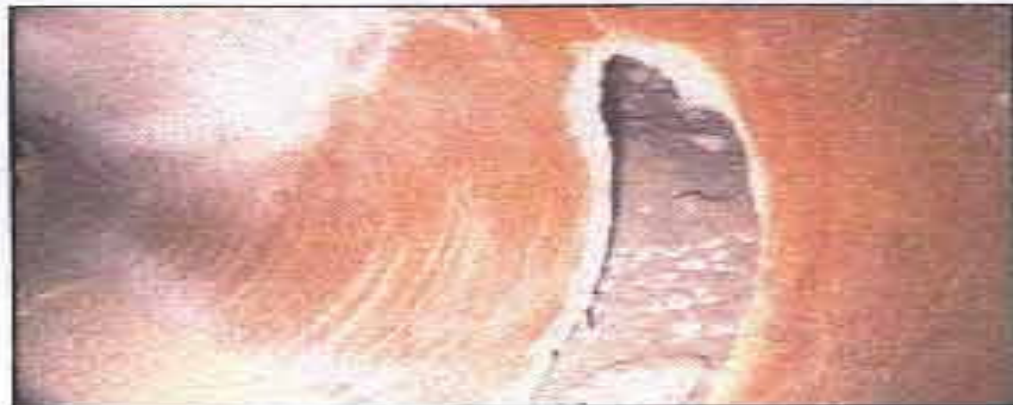
**Photo:** 3

**Position:** 268.50

**State:** MP—

Pipe damaged Circumferencial.  
3:00 to 9:00 o clock position

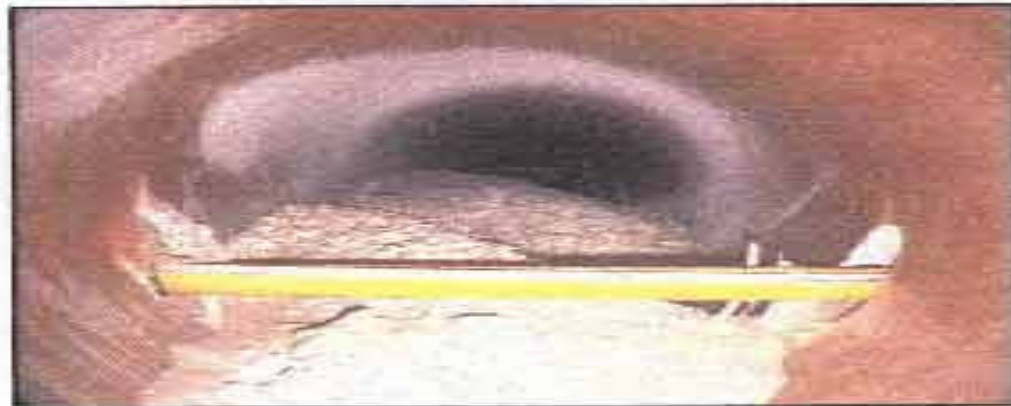
**Photo:** 4

**Position:** 270.20

**State:** PO—

Protruding Cable. pipe wall, 4:00 to  
8.00 o clock

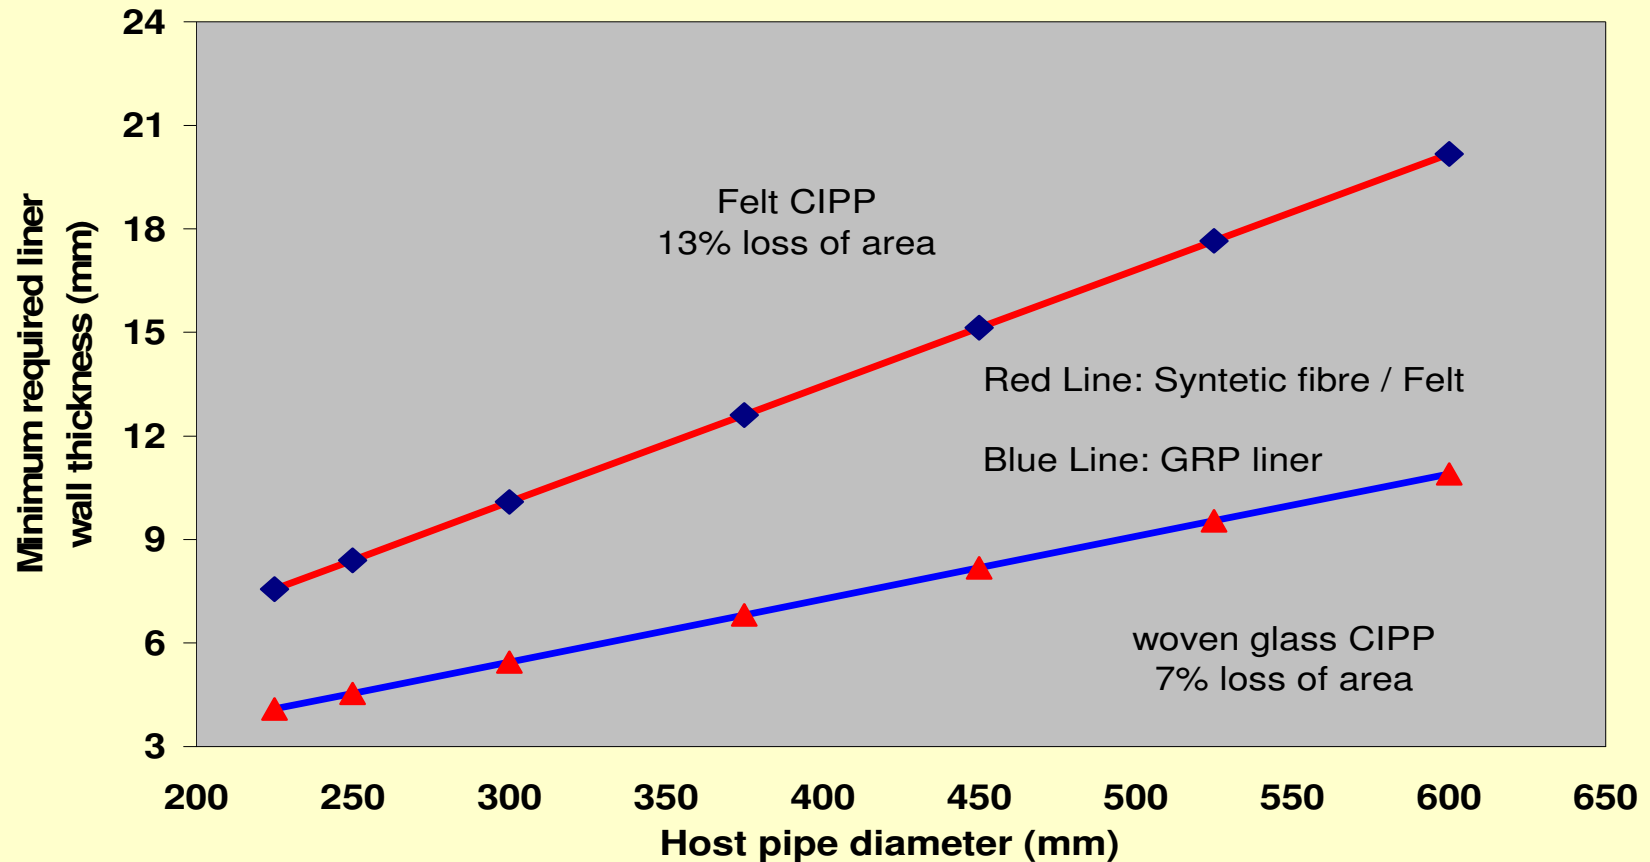
**CIPP WALL THICKNESS COMPARISON**  
 (for a long-term liner ring stiffness of 5000 N/m<sup>2</sup>)

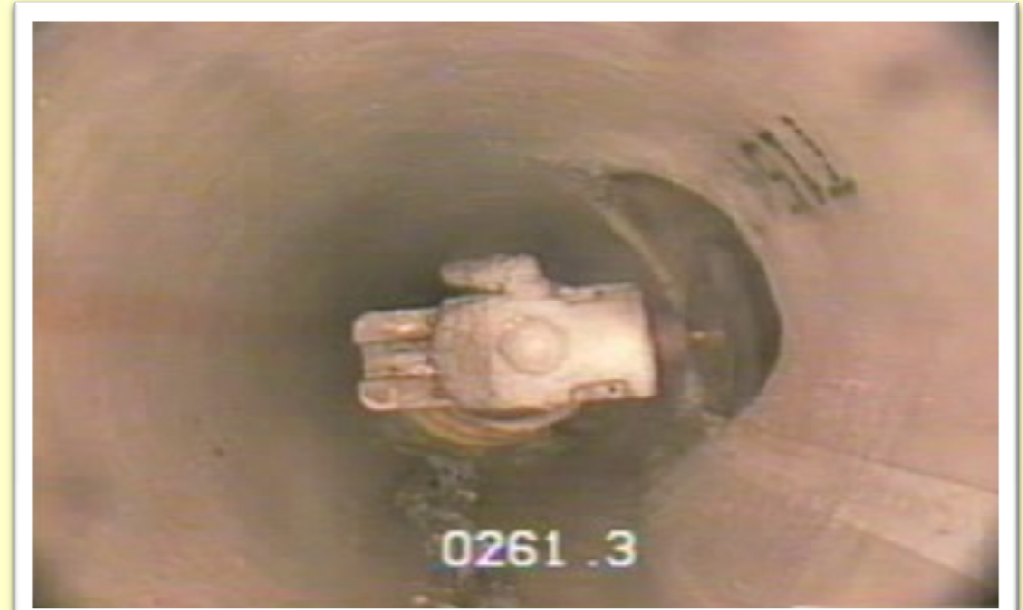
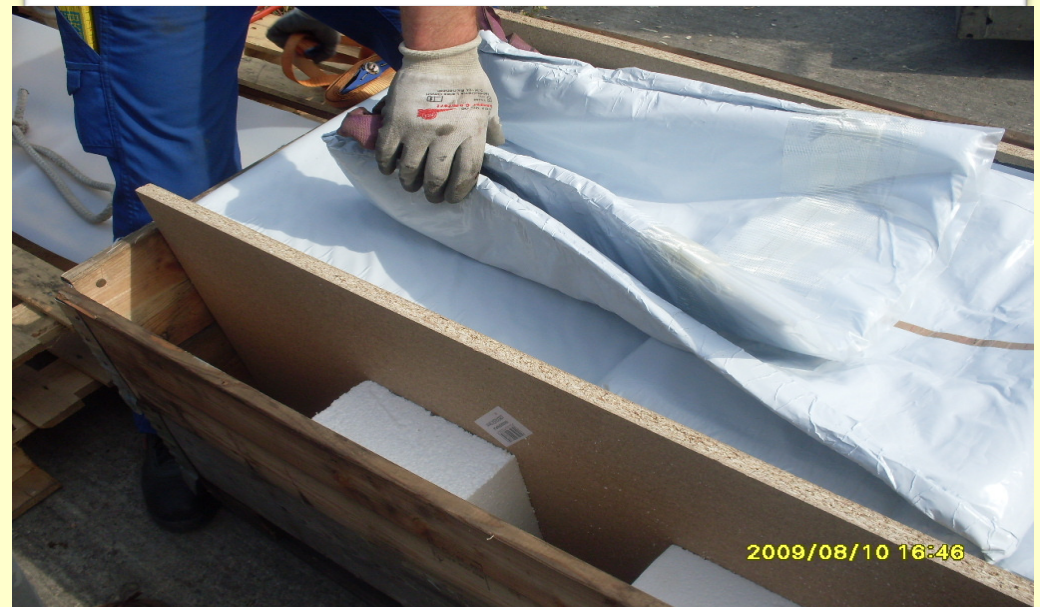
- Over pumping, Jet Cleaning & CCTV inspection and cutting sharp edges, if needed, must be done before the rehabilitation in order to get the host pipe ready for work.

- A resin is impregnated into a flexible tube of fiber reinforcement.

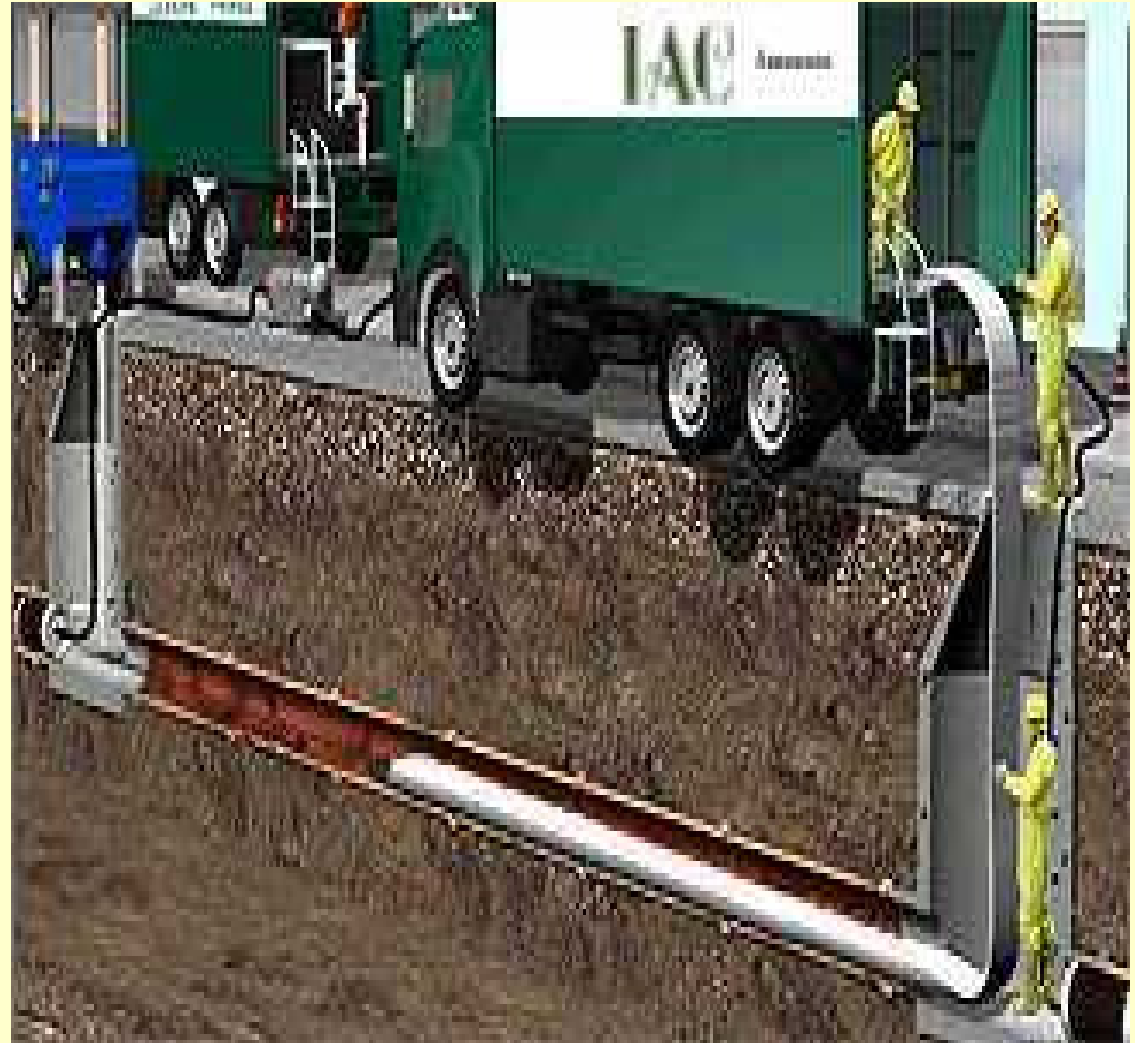
- The tube is then Winched In Place (WIP) into the pipe and held under pressure.
- Installed lengths up to 220m have been achieved.

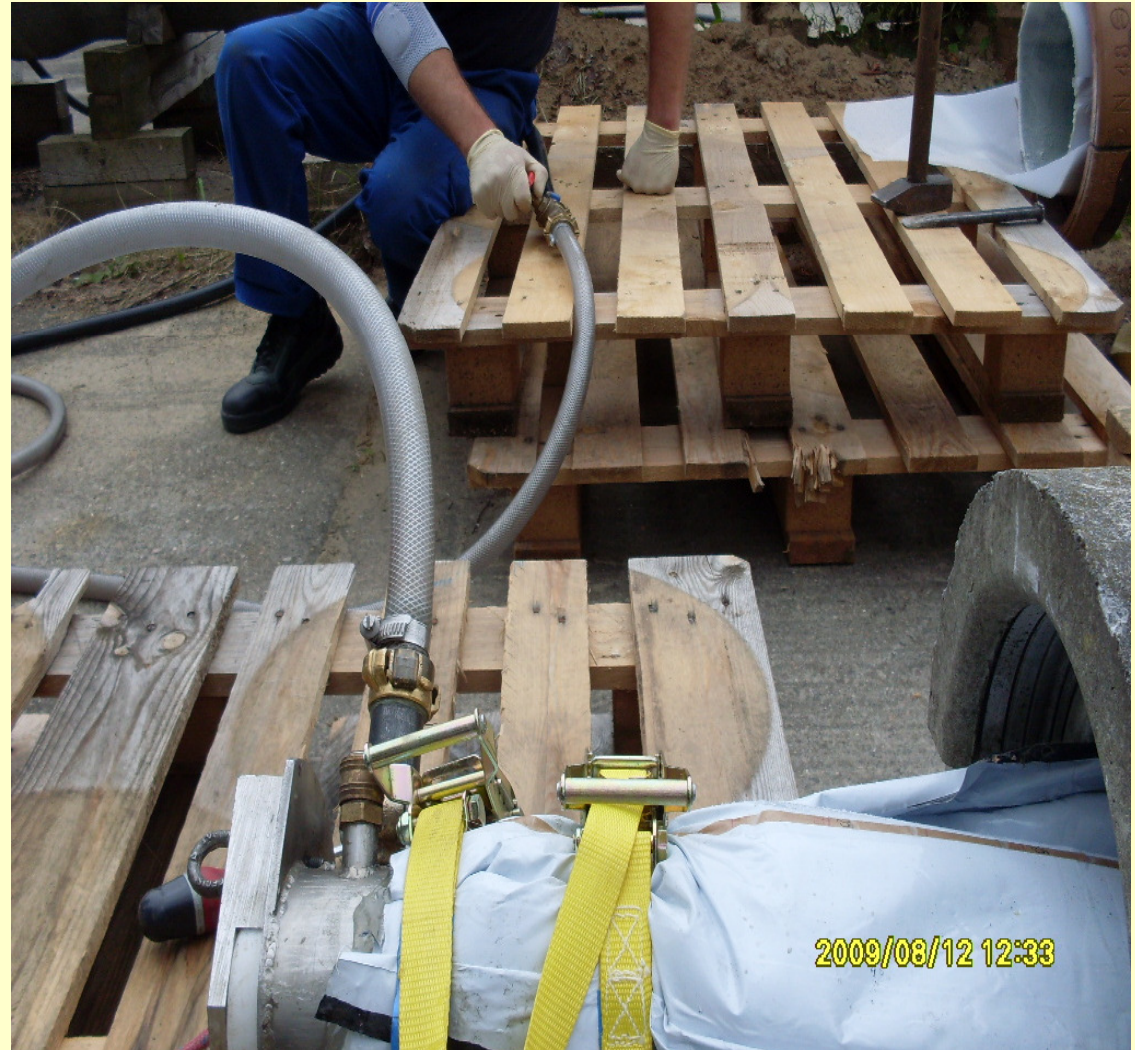
- A compressed air inflation process is used for field installation of the lining material.

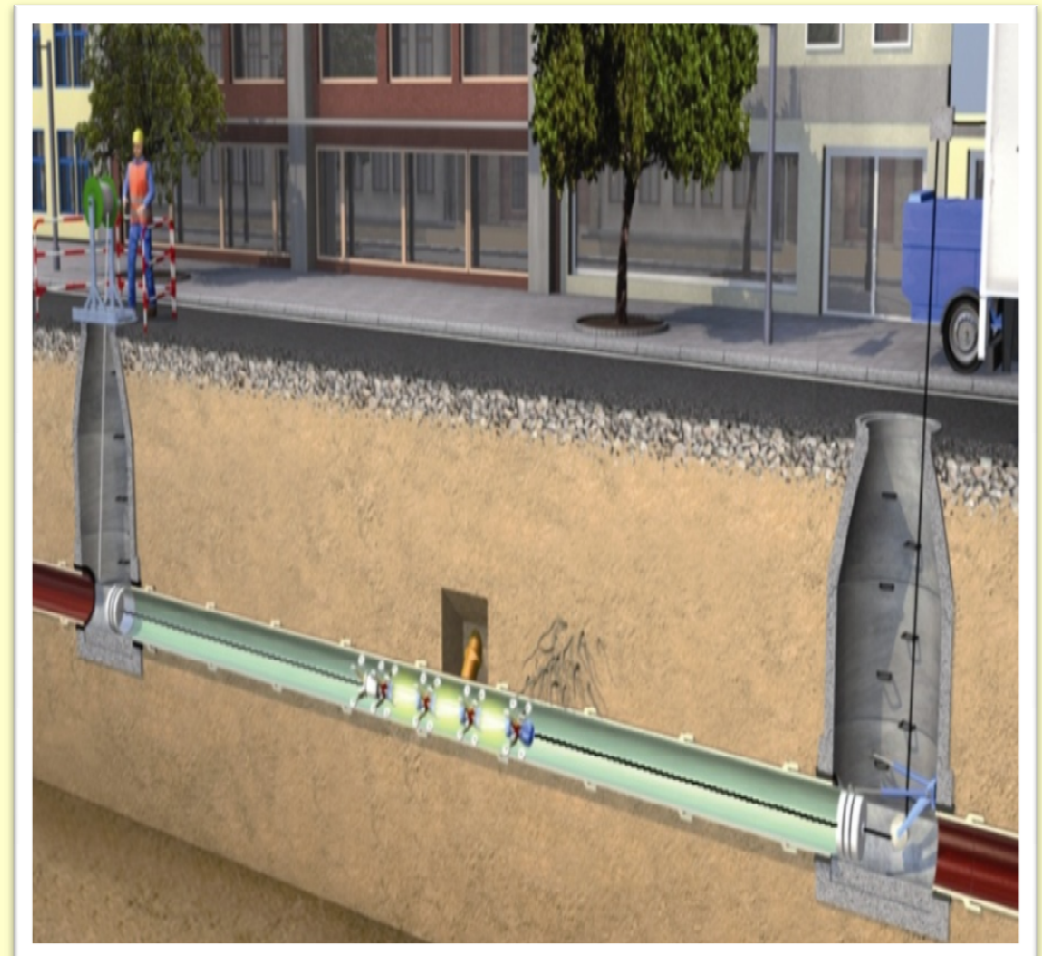
- Curing rates for light cured systems vary in relation to diameter and liner thickness but are typically 30m to 60m an hour.
- UV-light curing will not be effected by temperature or ground water around the pipe.

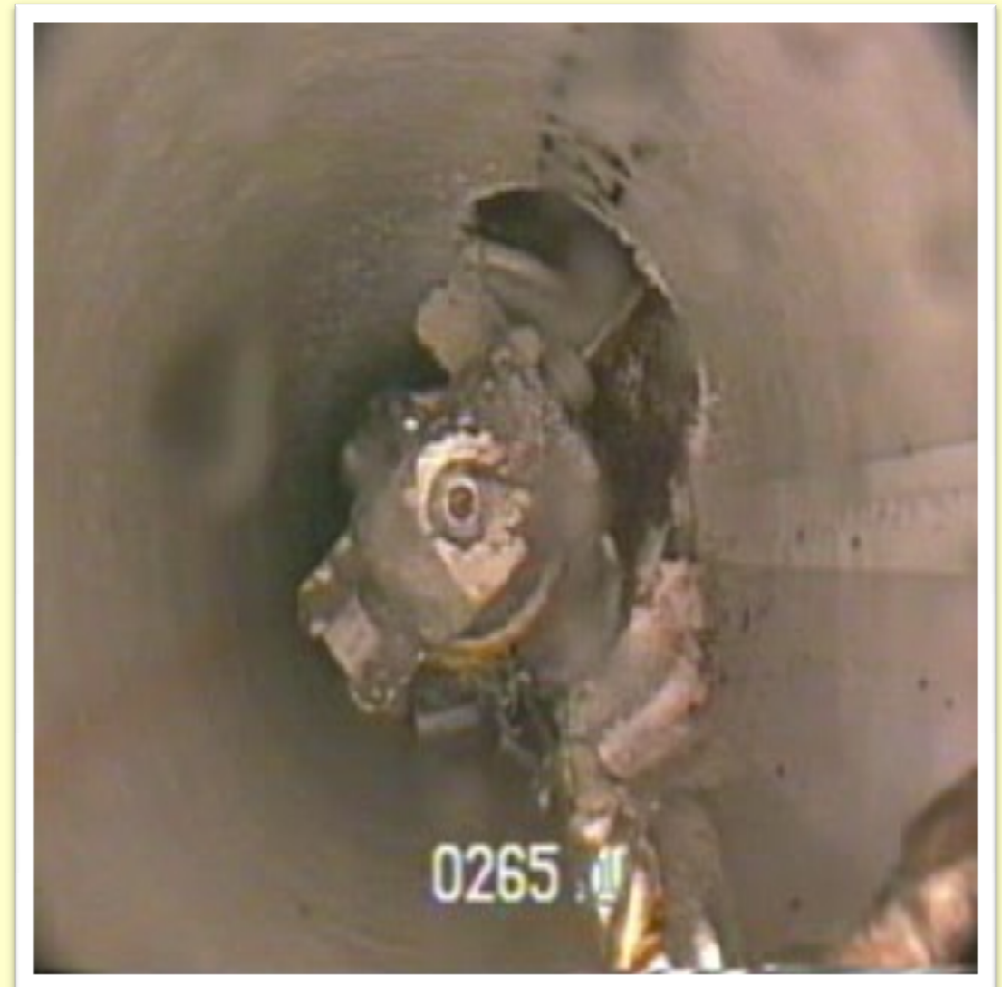
- Lateral re-opening can therefore be done immediately after curing of a UV-light system.
- Pipeline is ready for service.
